## NOVATO SANITARY DISTRICT

**ANNUAL OPERATIONS REPORT**  
**2014**  
**Veolia Water West Operating Services Novato**

**2014 ANNUAL OPERATIONS AND MAINTENANCE REPORT**  
**Novato Wastewater Treatment Plant and Ignacio Transfer Pump Station**

**Novato Sanitary District  
Wastewater Operations Committee meeting  
Collection System Operations Report  
February 2015**

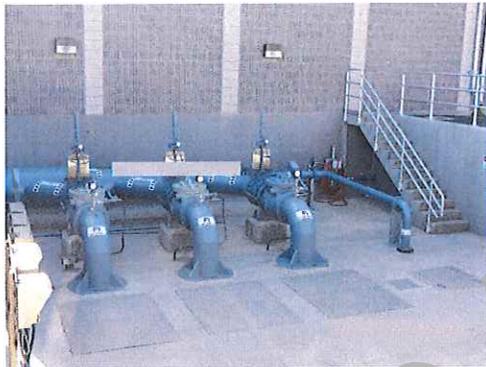
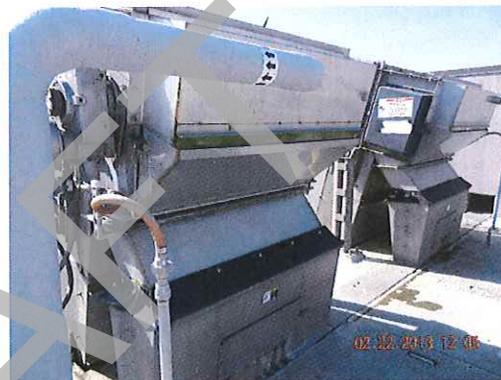
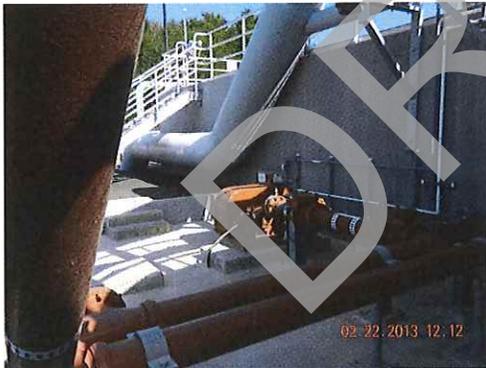
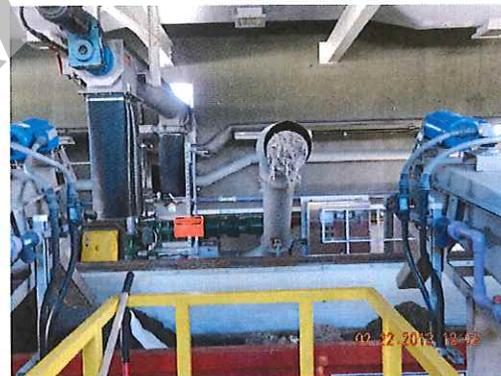
When the wastewater arrives at the Treatment Plant it is pumped from the Influent Pump Station to the Headworks. The Headworks provides screening of coarse materials and removal of grit which consists of heavy matter such as sand, silt, and gravel.

Top Left – Influent Pump Station

Top Right – Parkson Aqua Guard Screen™

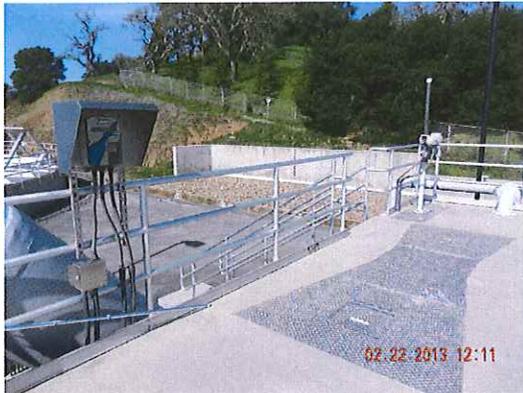
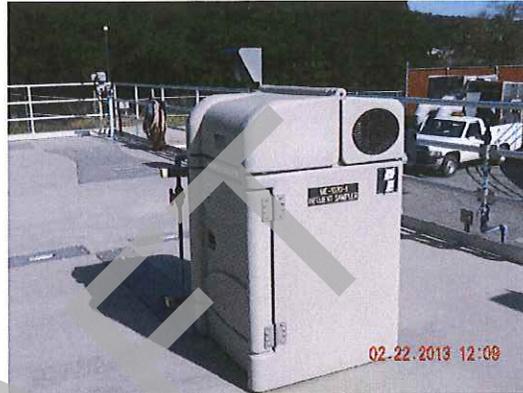
Flow at the Novato Wastewater Treatment Plant is measured using a Parshall Flume and Hydro Ranger™ ultra sonic level meter in combination. This pairing is considered very reliable and provides a high degree of accuracy. Composite samples for biochemical oxygen demand (BOD) and total suspended solids (TSS) are collected downstream of screening and grit removal. Composite samples are flow proportioned throughout the sampling period (normally 24 hours). Flow proportioning provides the most representative sample.

Above Left – Hydro Ranger level meter, hourglass shaped plating over Parshall Flume  
 Above Right – Hach Model 3540 SDR Composite Sampler

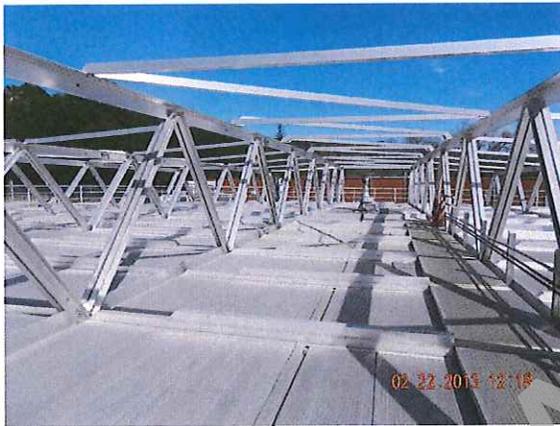
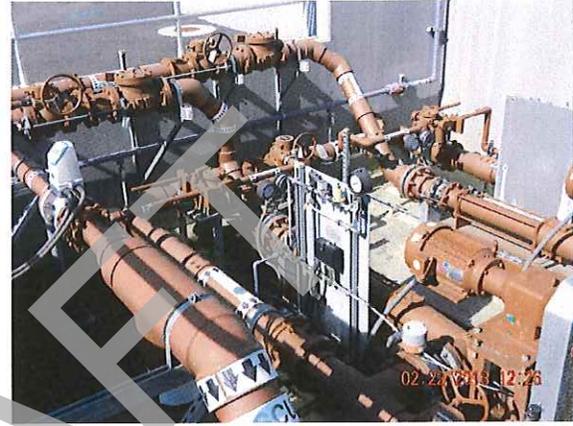
Primary clarifiers typically remove approximately 60 – 70% of the solids from raw wastewater. Clarifiers are large tanks that slow the flow of water and allow the force of gravity to remove solids. Heavier solids referred to as “sludge” settles to the bottom. Lighter material such as fat, oil, grease and plastic referred to as “scum” rises to the surface. Both sludge and scum are removed from the waste stream and pumped to a digester for additional treatment.

Above Left – Primary Clarifier #2, Superstructure supports the cover.  
 Above Right – Sludge and Scum Pumping

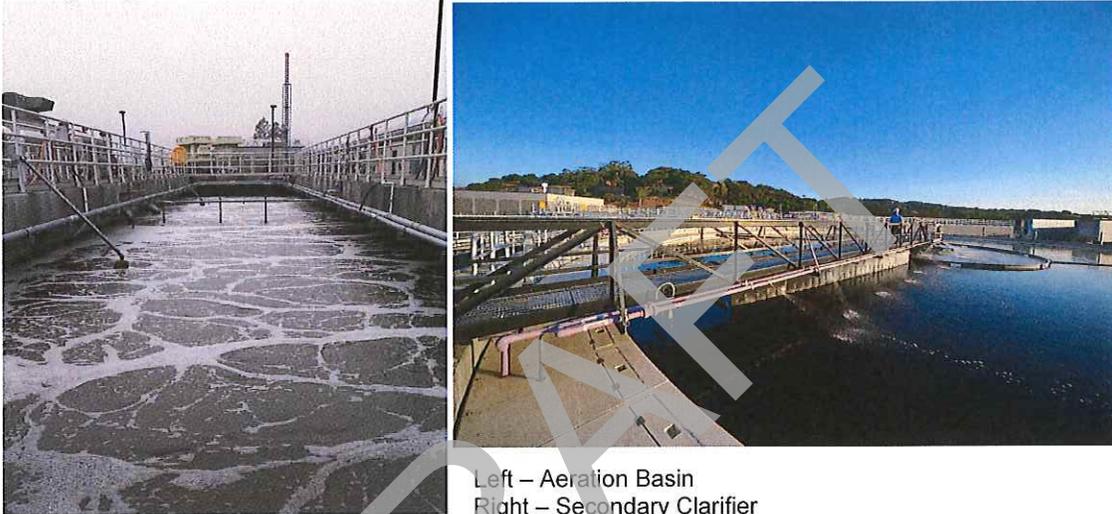
After screening, grit removal, and primary solids removal, all wastewater receives full secondary treatment. Large rectangular tanks with baffle walls, mechanical mixers, air diffusers, and recirculation pumps make up the aeration basins. The Novato facility was designed with both flexibility and reliability in mind. Four aeration basins, each with a capacity of more than 850,000 gallons provides complete secondary treatment under all flow conditions.

Each aeration basin has three anoxic (no dissolved oxygen) zones accounting for almost 25% of the tank volume. The anoxic zones convert nitrate and nitrite to nitrogen gas to reduce the level of total nitrogen in the effluent.

Left – Aeration Basin  
 Right – Secondary Clarifier

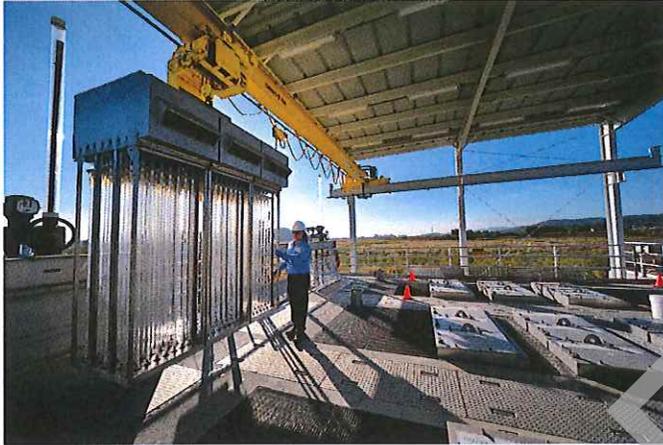
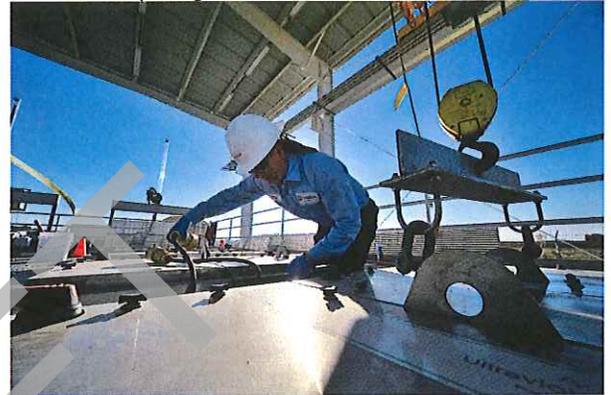
Prior to discharge wastewater must be disinfected. Ultra violet light disrupts the DNA of pathogens and other life forms leaving them incapable of reproduction. UV unlike other methods of disinfection uses no chemicals, produces no harmful byproducts (trihalomethanes for example), and leaves no toxic residual.

Left – UV Rack Removed for Cleaning  
Below – Preparing UV Rack for Removal

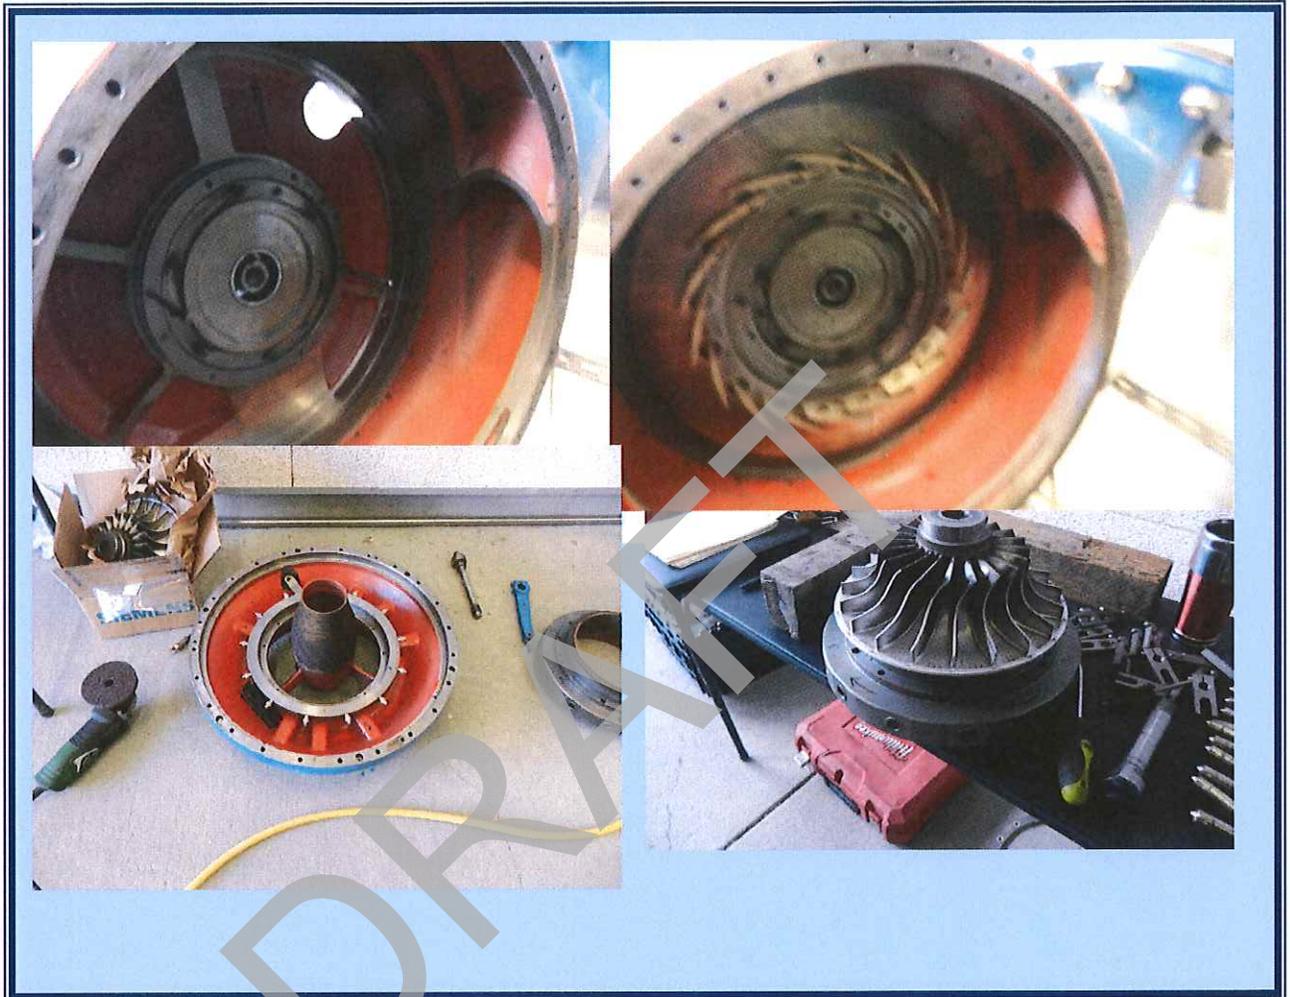
**TURBLEX BLOWER - 36,000 HOUR LEVEL ONE INSPECTION**

Complete disassembly of Turblex Blowers (1 & 2)  
Blowers were found to be in excellent condition

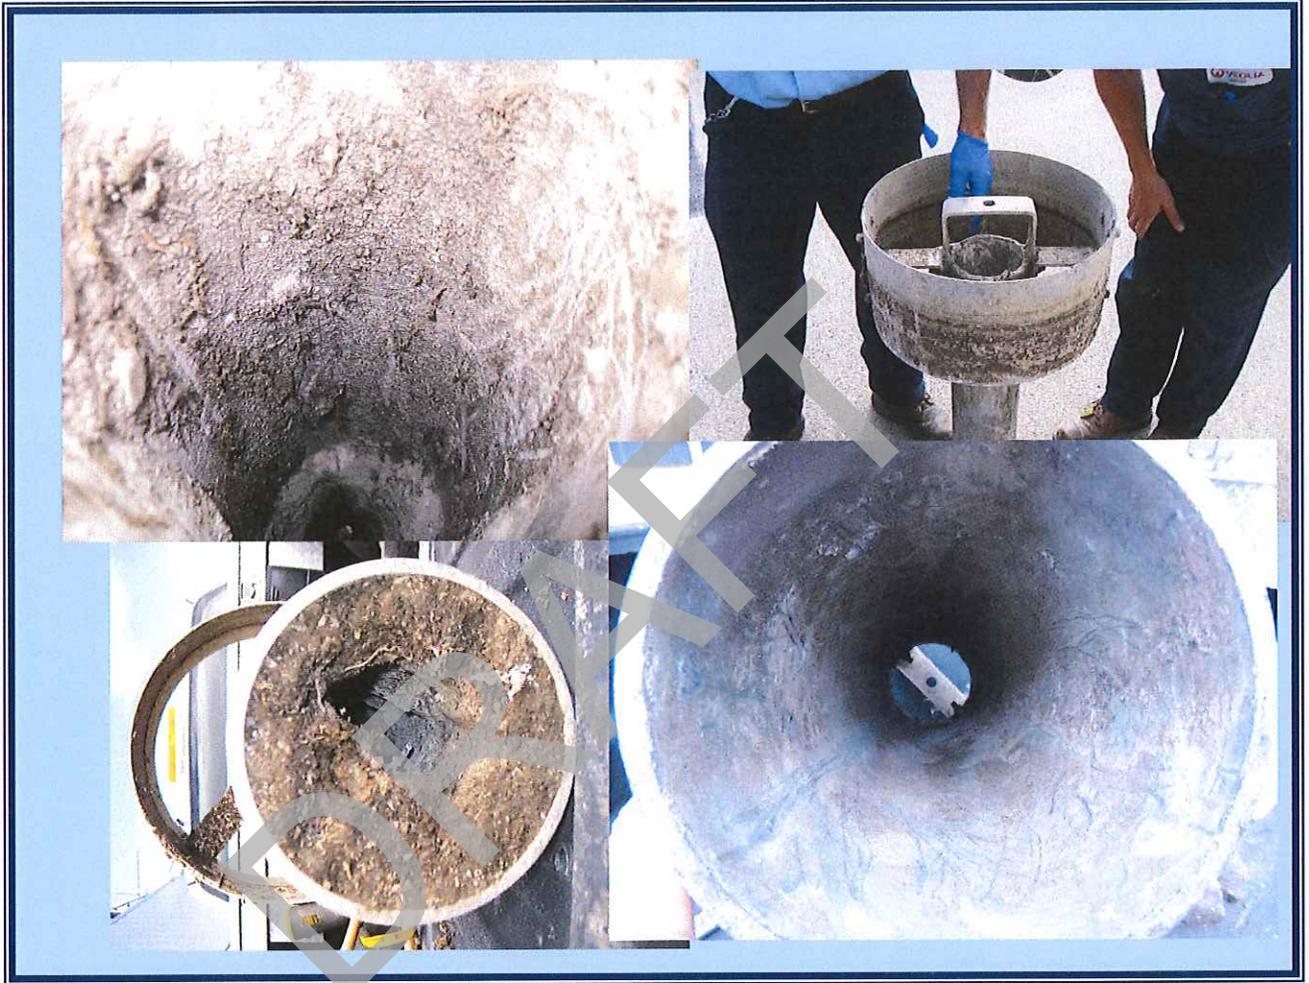
**REMOVAL AND CLEANING TELESCOPIC VALVE  
AT SLUDGE LAGOONS**

Top Left – Struvite Buildup in Telescoping Valve Receiver  
Top Right – Telescoping Valve Removed Ready for Cleaning  
Bottom Left – Buildup in Telescoping Valve  
Bottom Right – Cleaned Telescoping Valve

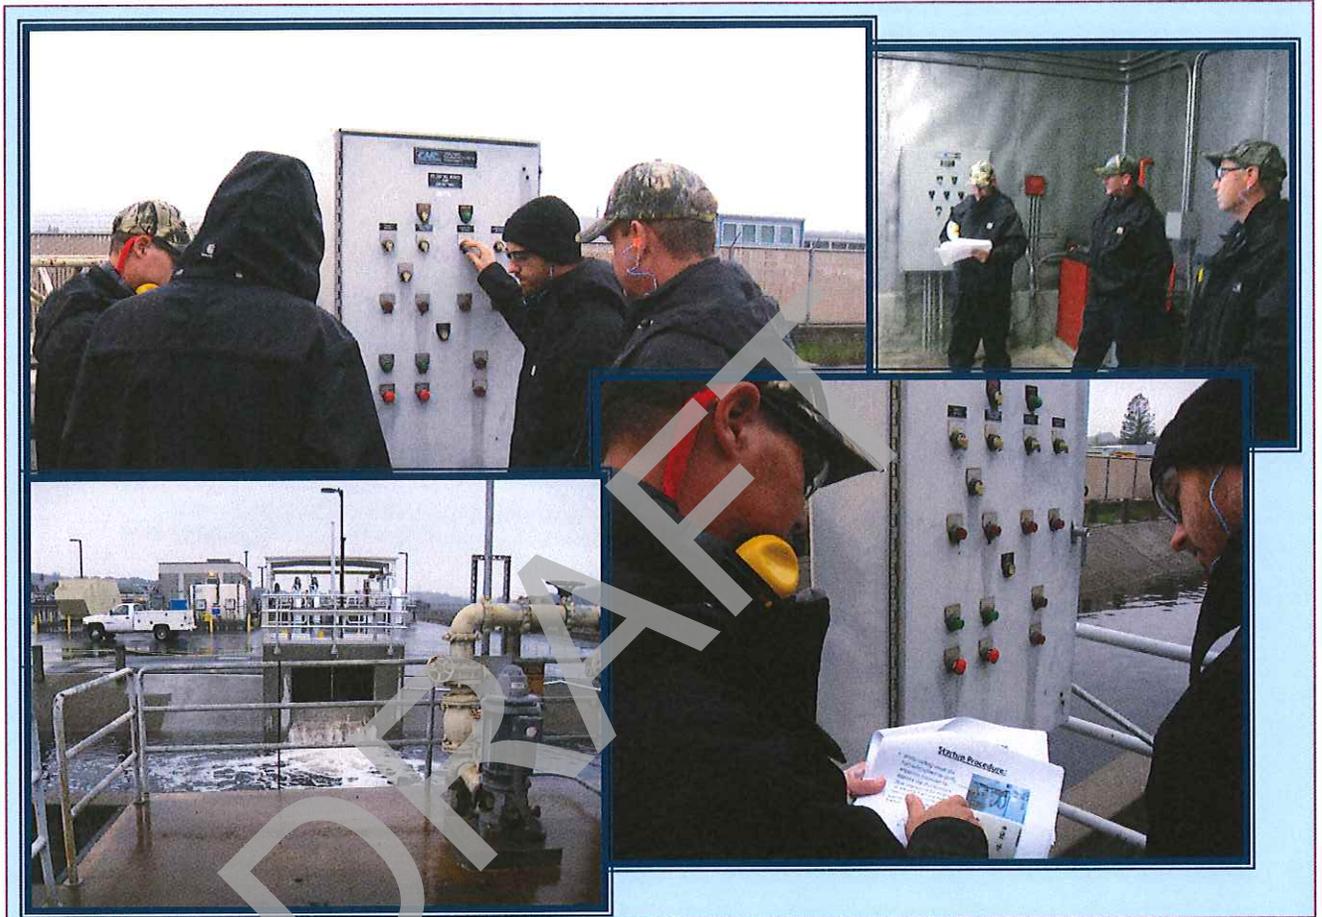
NOVEMBER 19<sup>th</sup>  
HANDS-ON REVIEW OF THE WET WEATHER SOP

**Training in November prepared staff for the heavy rains of December**

**Above Left – Operations and maintenance staff review operation of the (hydraulic) wet weather pump valves**

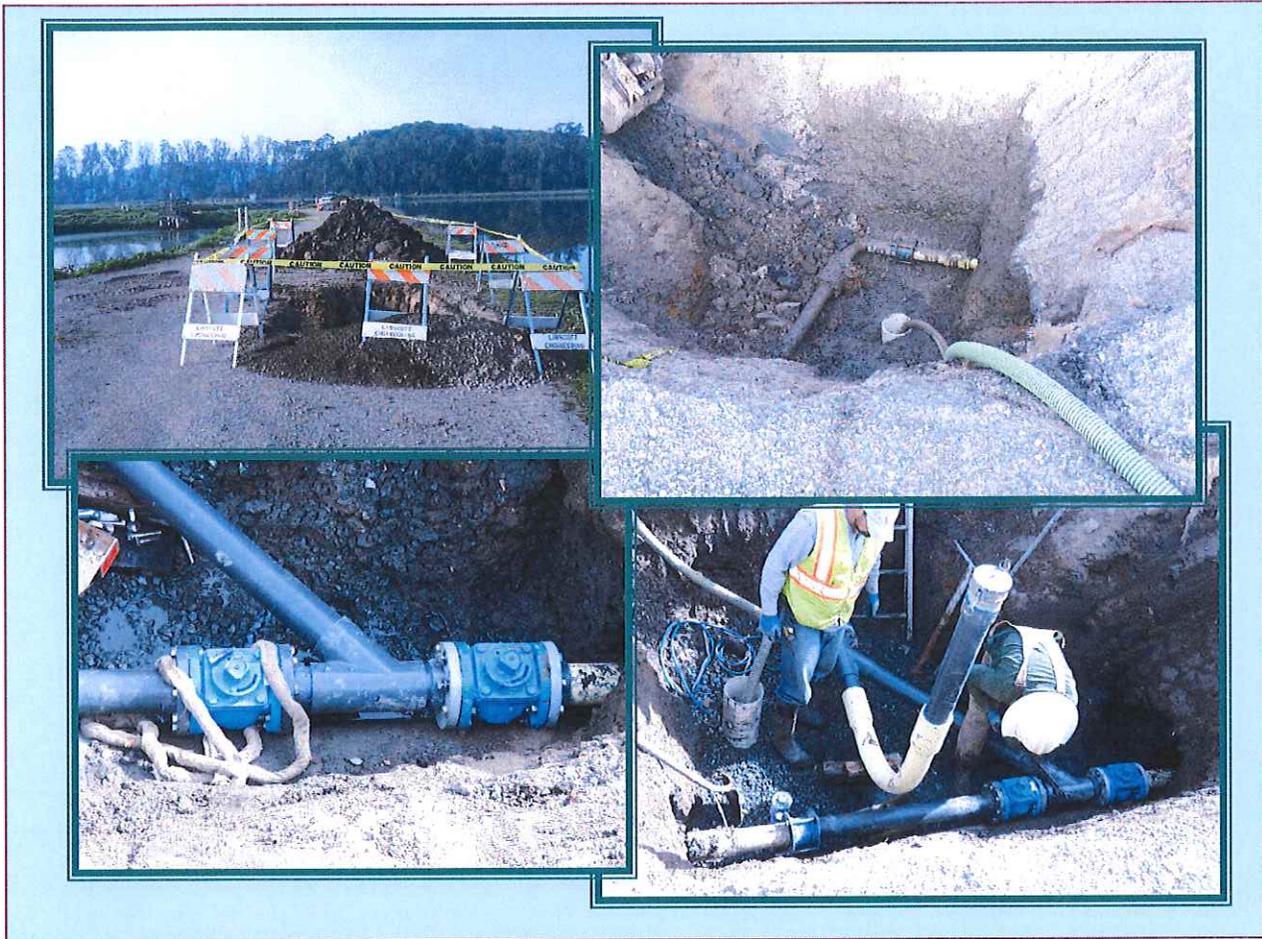
Top Left – Excavation of Sludge Feed Line to Lagoons #3, #4, #5, & #5

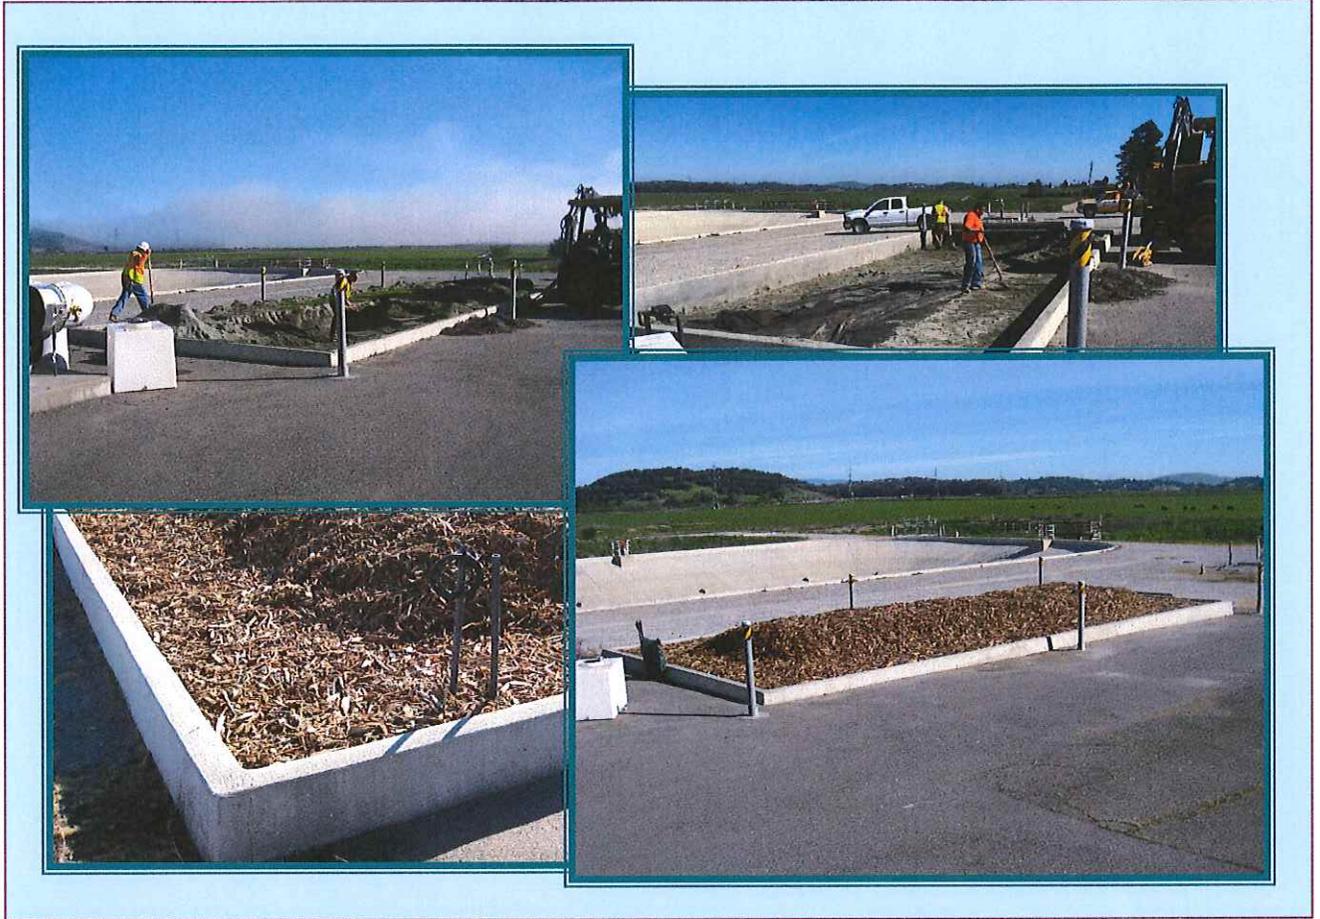
IGNACIO TRANSFER PUMP STATION  
BIOFILTER MEDIA REPLACEMENT  
February 25, 2015

Top Left & Right – Removal of old media  
Bottom Left – Closeup of new media  
Bottom Right – Biofilter with new media installed

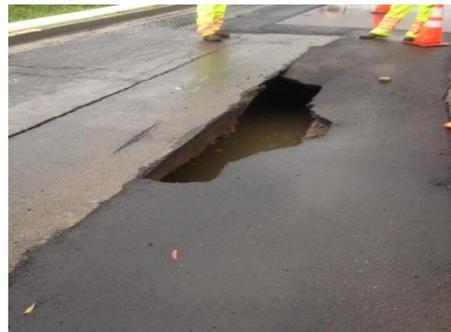
Discussion: On Friday, February 6, 2015 at 08:04, Javier Vega, CSW III, noticed an open sink hole along the trench line of the Olive Street Pump Station force main replacement project while enroute to perform daily pump station checks, so he pulled over to investigate the problem. The construction project and the trench failure were located on Railroad Avenue near Orange Street. At 08:05, Javier observed a car drive into the sink hole, causing damage to the vehicle.

Javier called Dasse de longh, Collection System Lead Worker, at 08:07 to inform him of the incident while he was securing the accident site with cones to direct traffic around the sinkhole. Javier checked the driver for injuries and calmed the driver, then called Novato Police Department to report the accident and to get help with traffic control at 08:09.

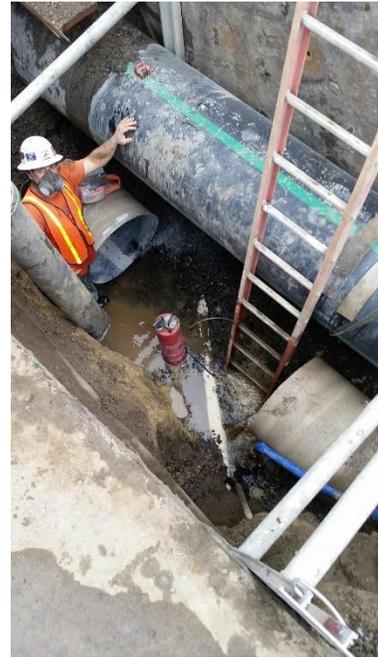
Staff determined that the cause of this discharge was likely the result of pipe failure on the existing force main. It is unclear what caused the force main pipe to fail. The force main is constructed of Techite pipe, a material now known in the industry as prone to failure and it is one reason the District is completing the force main replacement project. Also, during the repair, an unknown white PVC pipeline was found directly under the pipe failure location (see photo at right).

The District and the contractor mobilized in a joint effort to secure pumps, parts, & manpower to repair the force main. All of the repair parts necessary were not readily available so a temporary repair was made. The permanent repair was completed a week later. The force main replacement project should be completed by March or April, 2015.

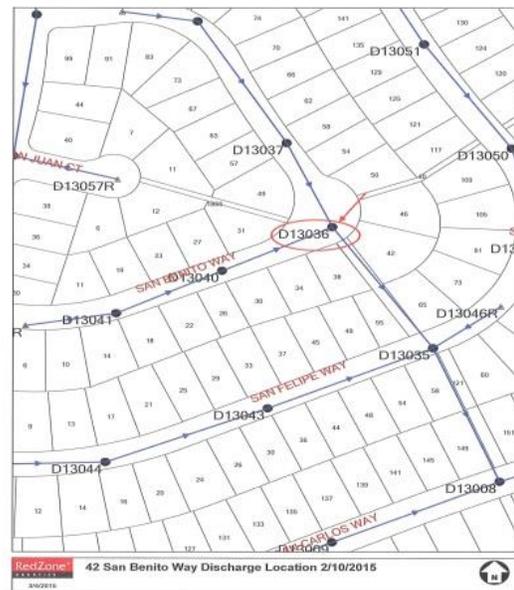
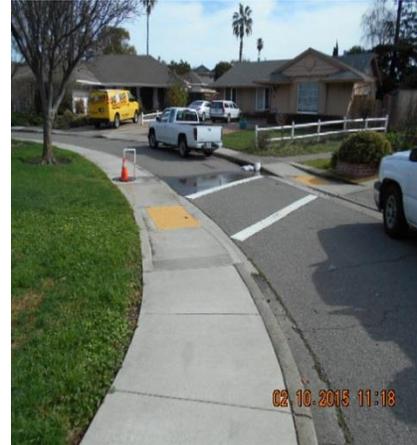
On Tuesday, February 10, 2015 at 11:00, Tim O'Connor, Collection System Superintendent, received a call from Robin Merrill, Information Systems Specialist II, reporting a possible overflow at 42 San Benito Way. Tim contacted Javier Vega, CSW III, and Aaron Hendricks, CSW I, who were on the hydro-flusher, and Dasse de longh, Collection System Lead Worker, and directed them to respond immediately to the site.

Tim proceeded to the site and arrived at 11:12, at which time he took pictures and implemented containment protocols. Javier and Aaron arrived on site with the hydro-flusher at approximately 11:15 and setup on manhole D13035 on San Felipe Way to relieve the stoppage. During setup, they noticed flow in the downstream manhole,

Tim interviewed the reporting party, Lita Carroll, by phone, and she said that she noticed the discharge during her morning walk (at ~11:00am), and called it in immediately. Tim then interviewed four residents in the immediate area of the discharge, none of whom saw the discharge. Tim then interviewed Mark Ross with One Hour Heating and Air Conditioning who drove over the discharge site at 10:00 enroute to 46 San Benito Way. Mr. Ross stated that the overflow had not started at that time. Tim estimated a start time of 10:30 based on these interviews and a discharge rate of 1.4 gallons per minute using the "Water Height Above the Pick-hole Method" (from the District's SSO Response Plan) for a total estimated discharge volume of 70 gallons.

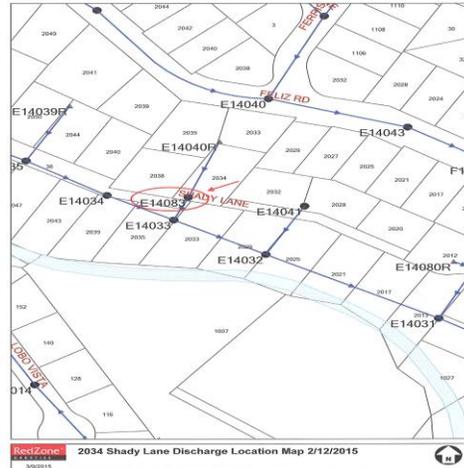
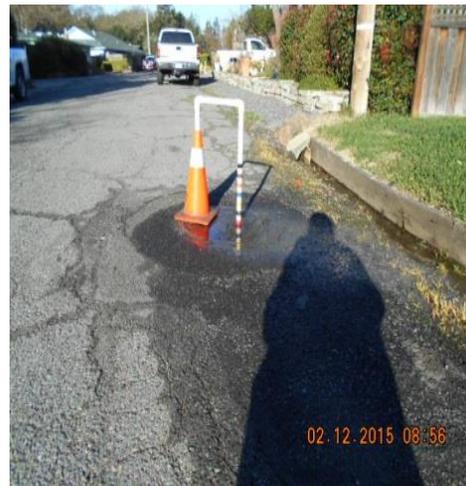
Tim proceeded to the site and arrived at 08:45, at which time he took pictures and implemented containment protocols. Bob and Justin arrived on site with the hydro-flusher at approximately 08:51 and setup on manhole E14083 and vacuumed the water out of the manhole, temporarily alleviating the overflow at 09:00. The crew was unable to access downstream of the discharge manhole because it is a blind tie-in. Tim authorized them to carefully clear the stoppage from the upstream side using a hydro-flusher. Bob and Justin relieved the blockage at 09:36 and began cleanup operations.

Tim interviewed the reporting party, Maria Cuevas, and she stated that her husband had seen the discharge two (2) days earlier. Tim asked her if she could call her husband to clarify the time when he had first noticed the overflow. Mr. Cuevas said that he had noticed the overflow on Tuesday, February 10, 2015 at approximately 07:00 when he left for work. Mrs. Cuevas asked Mr. Cuevas why he had not mentioned the problem sooner and he said that he was too busy to call anyone about the discharge. Tim then interviewed four residents in the immediate area of the discharge and only Brenda Roberts at 2038 Shady Lane saw the discharge. Mrs. Roberts also stated that she saw the manhole weeping on Tuesday, February 10, 2015 at about 07:00. Both people who saw the discharge said that it was an intermittent event and did not discharge continuously. Tim determined a start time of 06:30 on February 10, 2015 based on these interviews and used residential winter water use records to calculate a total estimated discharge volume of 452 gallons.

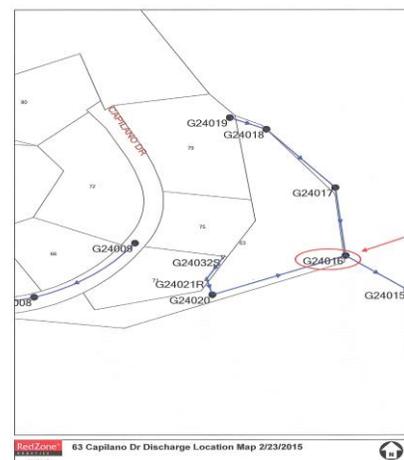
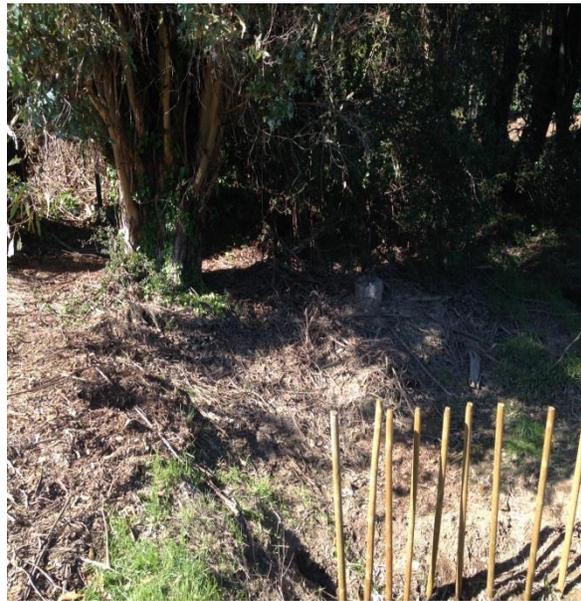
Tim proceeded to the site and arrived at 09:43 and inspected the overflow site. Bob and Javier had blocked a storm drain inlet, after observing a trickle of water leading to the inlet, approximately 40 feet away from the discharge manhole (G24016). They then set up the mechanical rodder on the downstream manhole to remove the blockage. Bob and Javier relieved the blockage at 09:35 and began cleanup operations. Initial observations of the discharge area found the area to be composed of highly absorbent leaf litter debris and sandy

Tim interviewed Scott Thomsen, Assistant Golf Course Superintendent in an effort to establish a probable start time for the discharge and to determine where the golf course drainage lines were installed. During this first interview, Tim determined that the discharge may have reached a pond on the course that is part of the Arroyo de San Jose Creek. Staff vacuumed approximately one hundred and ten gallons of mixed runoff and overflow water from a runoff collection box in line with the discharge location, but prior to reaching the pond. During subsequent interviews with Mr. Thomsen, Tim estimated a start time of midnight, February 13, 2015. Based on these

interviews and using residential winter water use records of homes tributary to the discharge manhole, Tim was able to calculate a total estimated total discharge volume of 1,872 gallons. Based on staff observations and consultations with Mr. Thomsen, Tim estimated that approximately ninety-five percent (1,778 gallons) of the discharge soaked into open ground with potentially five percent (94 gallons) reaching a waterway.

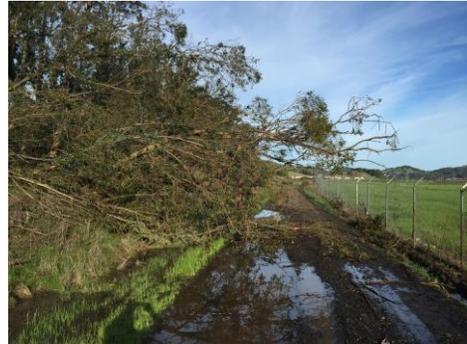
A Work Order was issued to fill in potholes along the access road which were exacerbated by the water crossing the road. Also, several trees have fallen out of the eucalyptus grove, knocked down by heavy winds and wet soil conditions (see photo at right).

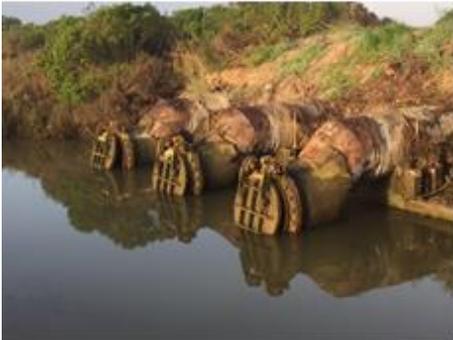
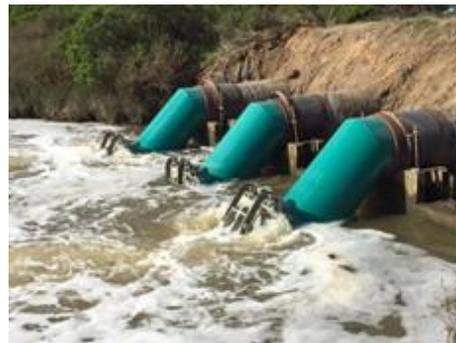
The contractor for the Drainage Pump Station Improvement Project continued working on the project as weather, tides and conditions allowed. The contractor completed installing the structural steel for the new pipe supports and also installed the new discharge pipe ends with flap gates at each pump station (see photos below). Debris fencing around the pump wells at each station remain to be installed.
